Technical Information Bulletin

Subject: Feed Tray & Side to Side Registration **BULLETIN NO.: 137**

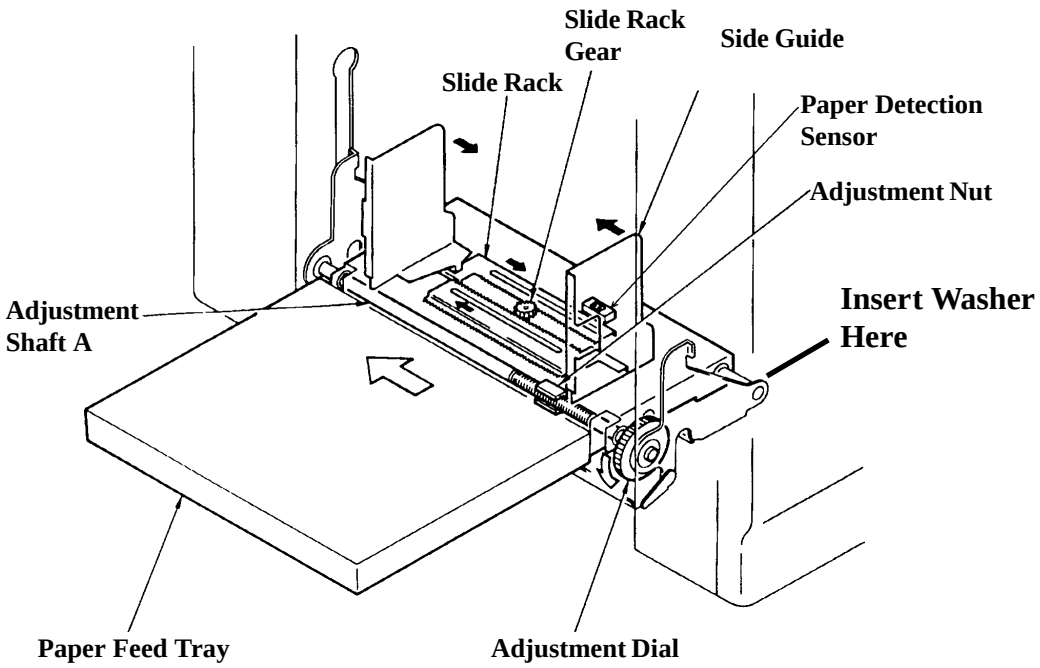
Some Paper Feed Trays have excess side to side movement.
Excess side to side movement may effect side to side registration. This is noticable on a second pass.

Insert a washer on the shaft between the C-clip and the paper feed tray.
The hole in the washer should be 10mm to 12mm, the outside diameter should be 14mm to 20mm and the washer thickness should be 1mm to 3mm.
